Subject: Department of Natural Resources Washington Geological Survey,
School Seismic Safety Assessment Project, Contract No. AE 410 -
Seismic Evaluation for **Pasco School District**

1. Edwin Markham Elementary School, Main Building

Table 1-3. Identified Structural Seismic Deficiencies for Pasco Edwin Markham Elementary School Main Building

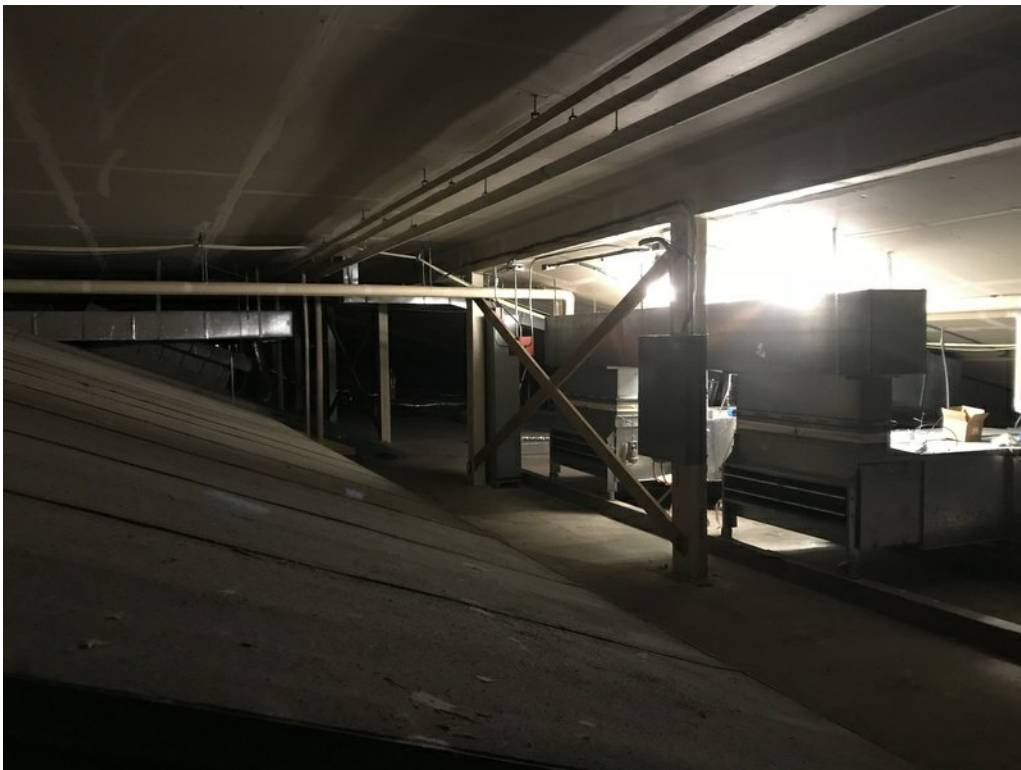
Figure 1-4. Mechanical attic on original roof structure and below new roof.

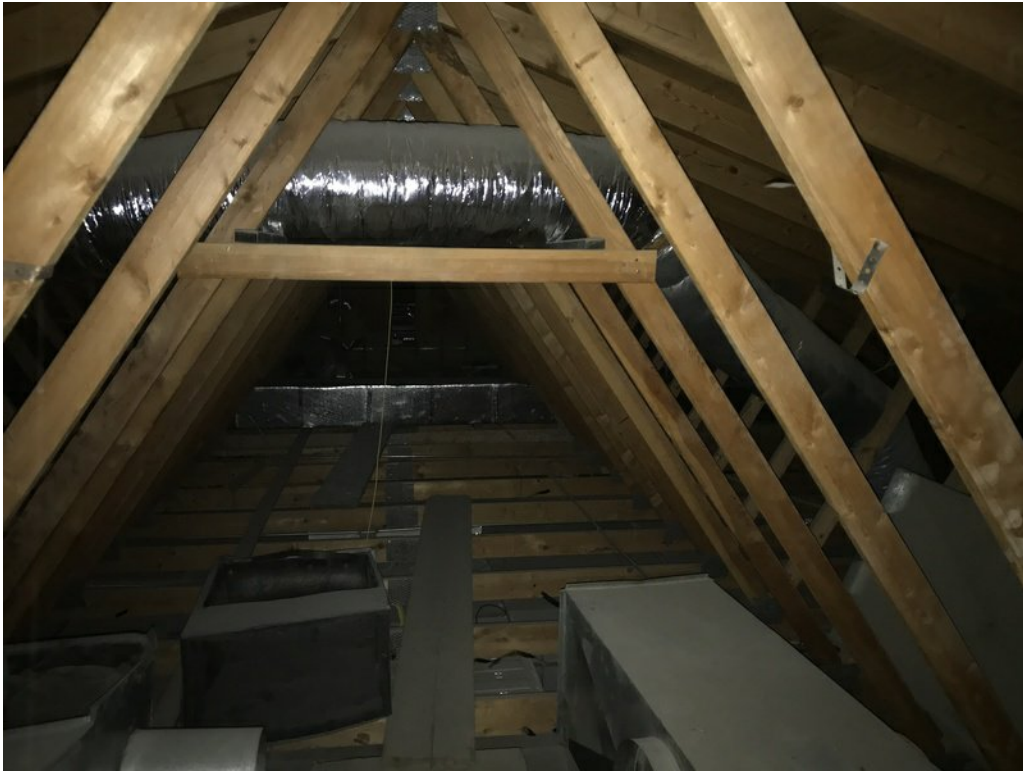
Figure 1-5. Wood trusses over addition.

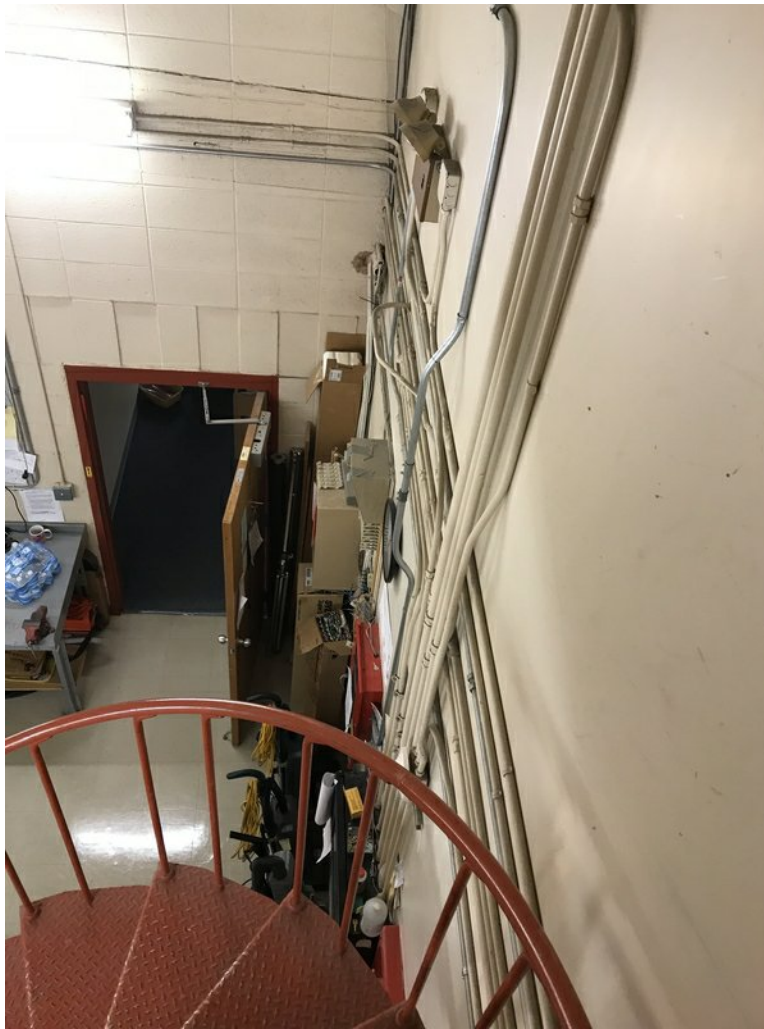
Figure 1-8. Access to mechanical attic - a spiral staircase in a large mechanical room.

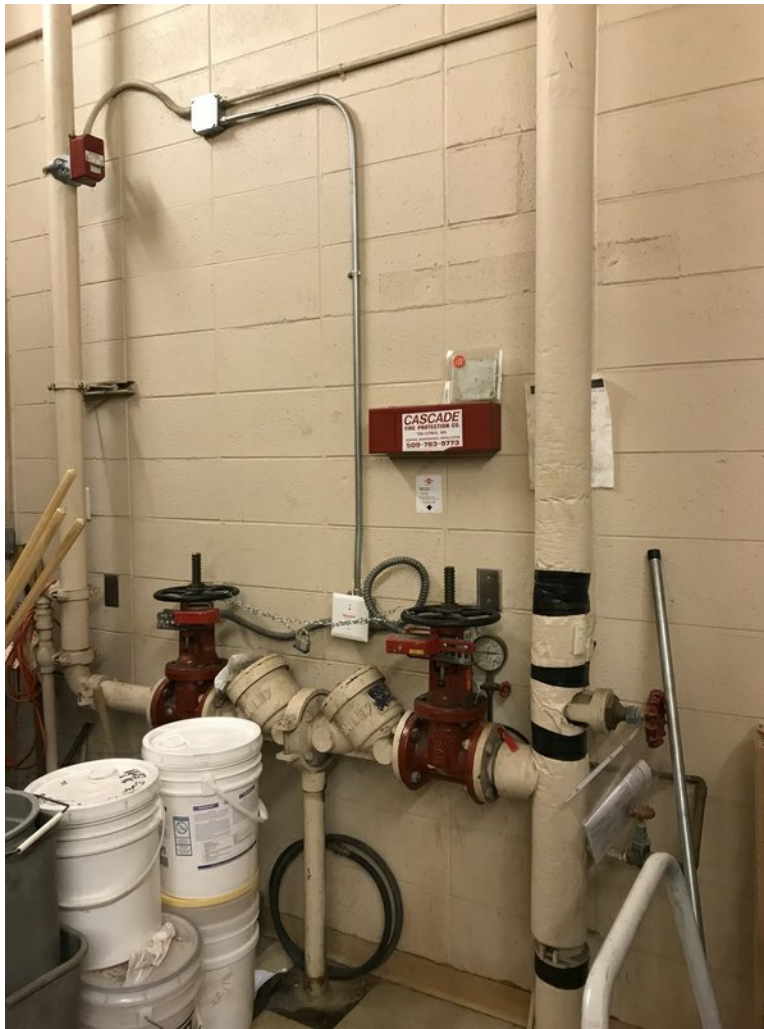
Unknown Item	Description
LSS-1 Fire Suppression Piping. HR-not required; LS-LMH; PR-LMH.	A fire suppression system was observed in the cafeteria but full details of the system were unavailable to determine compliance with NFPA-13.
LSS-2 Flexible Couplings. HR-not required; LS-LMH; PR-LMH.	A fire suppression system was observed in the cafeteria but full details of the system were unavailable to determine compliance with NFPA-13.
LSS-5 Sprinkler Ceiling Clearance. HR-not required; LS-MH; PR-MH.	A fire suppression system was observed in the cafeteria but full details of the system were unavailable to determine compliance with NFPA-13.
C-2 Suspended Gypsum Board. HR-not required; LS-MH; PR-LMH.	The details of the ceiling bracing were not available.
LF-1 Independent Support. HR-not required; LS-MH; PR-MH.	Lay-in light fixtures in suspended ceiling systems were observed, but the bracing details of those fixtures could not be verified.

Figure 1-9. Fire suppression piping mounted to a CMU wall within the mechanical room. The wall is part of the original structure.
